Project Title: *The John Deere E diesel Test & Research Project*

Durability Test Results of Three Non-Road Tier II Diesel Engines Operating on 10% Ethanol-90% Diesel Blend

Final Report

October 2006

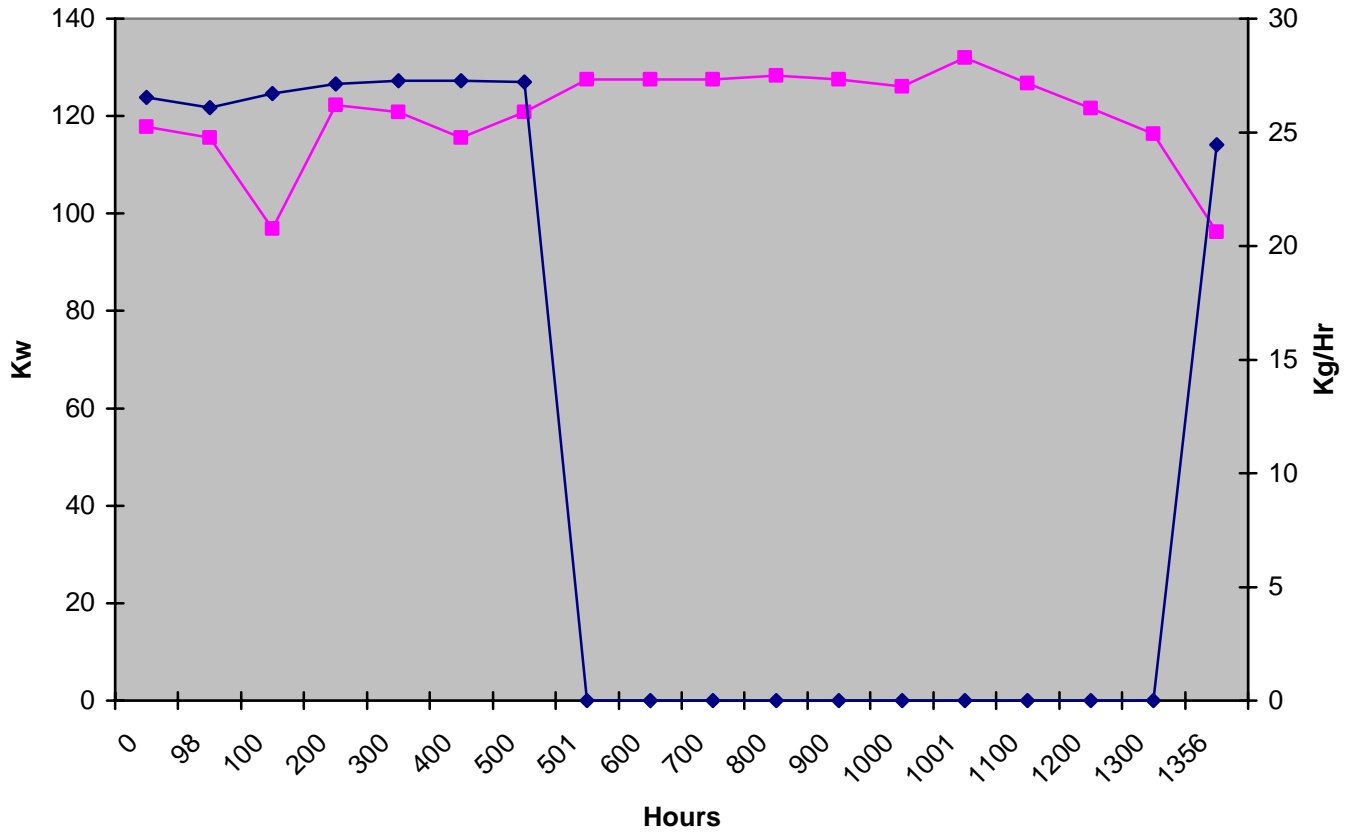
Graph 1 - 6.8 liter Engine Test Power and Fuel Rate

- Started test 13 July 2005
- Power loss caused by #5 injector tip failure @ 97 hours; replaced #5 injector
- Test cell fire caused by ruptured test cell fuel return line @ 170 hours
- Power loss caused by #4 injector tip failure @ 177 hours; replaced all injectors

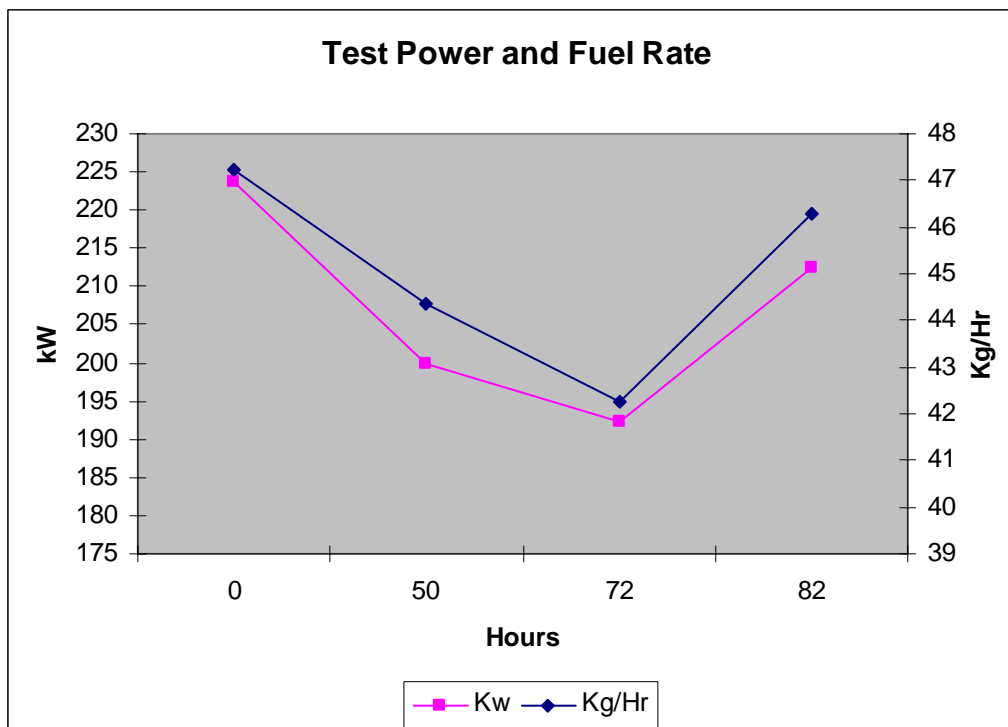
Graph II- 8.1 Liter Test Power and Fuel Rate – Run #1

- Started durability test on 10 March 2004; Fuel blend additive A
- Power loss @ 72 hours; diagnosed as malfunctioning injectors; terminated test

During 72 hours of test operation (10 March 2004-12 April 2004) the observed power level deteriorated from the expected 98% of #2D power (considered normal for E10 diesel based on previous emissions testing) to 86% of test start power. Hard starting and misfiring was also reported by the test operators. The usual diagnostic procedures (ECU signal, wiring harness integrity, excess flow valve function and fuel filter plugging) yielded no improvement. Replacing all of the electronically actuated fuel injectors resulted in a return to expected test power. Testing was terminated awaiting failure mode identification.

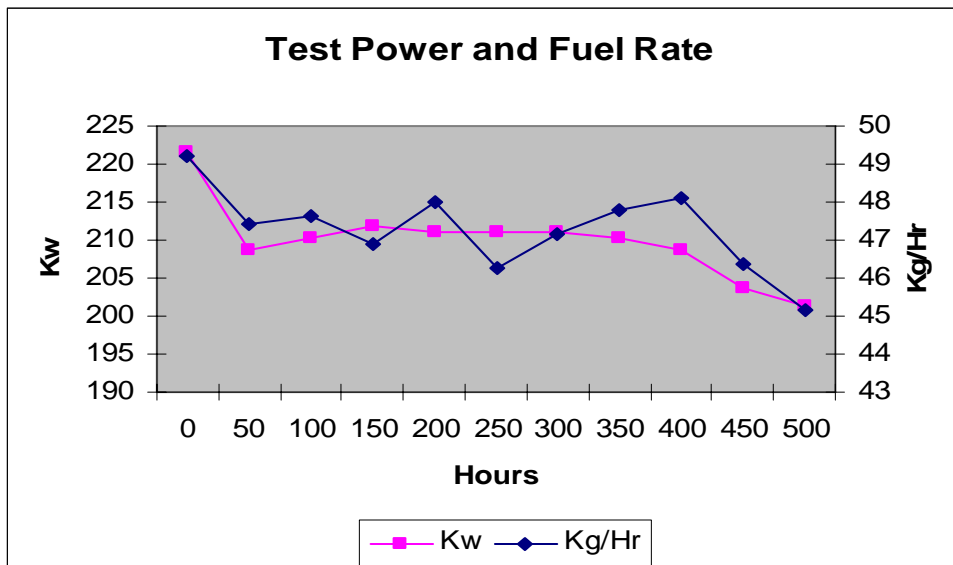
Graph III- 8.1Liter Engine Test Power and Fuel Rate – Run #2

- Restarted test 02 November 2004 with new injectors and fuel blend with Additive C
- Hard starting reported 440- 500 hours
- could not develop acceptable power for emissions test; diagnosed malfunctioning injectors
- Terminated test on 06 December 2004

Run #2 of the 8.1 Liter engine operated between 02 November 2004 and 06 December 2004. Power levels started out at 99% of rated power and gradually deteriorated to 90% of test start by 500 hours. Hard starting was noted at 440 hours and the engine was unable to complete the scheduled 500 hour emissions test. Diagnostics again indicated faulty injectors and they were returned to Denso for in-depth analysis. The inspection results were similar to the injectors from Run #1.

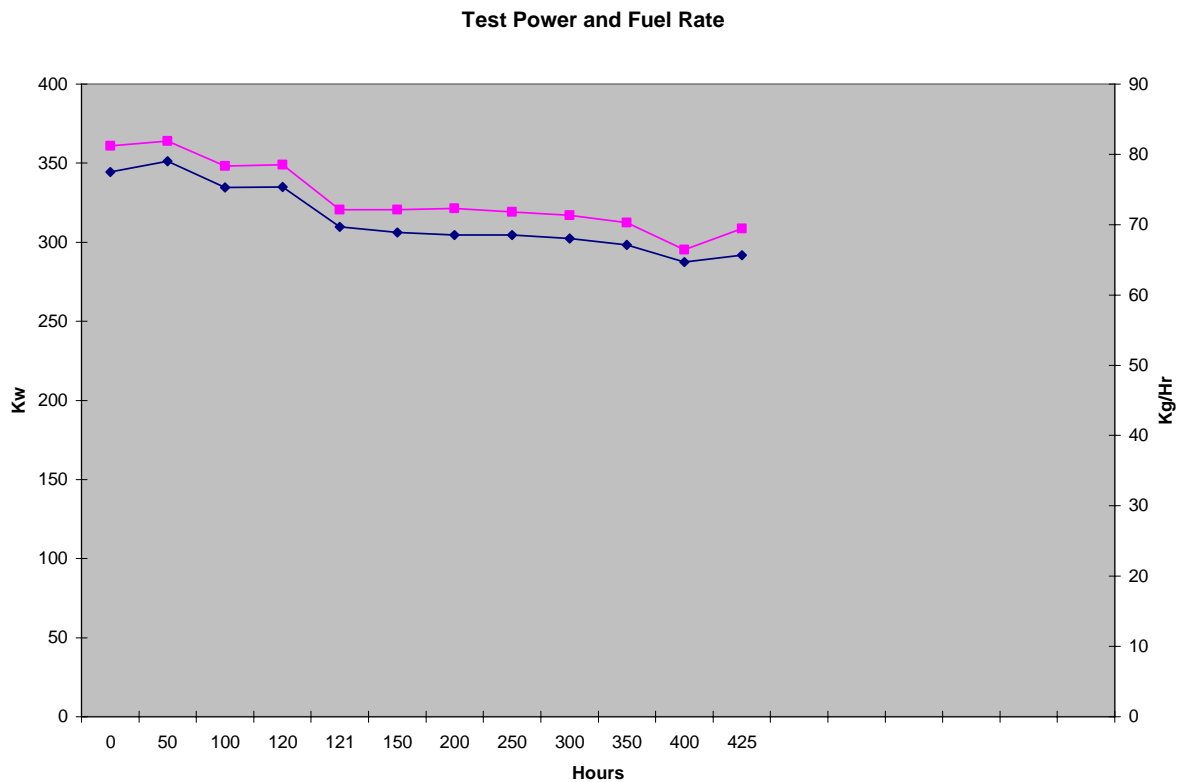
Graph IV- 12.5 Liter Test Power and Fuel Rate – Run #1

- Start test 08 June 2004
- 8% power loss @ 120 hours
- 10% power loss by 306 hours; diagnosed malfunctioning injectors
- Terminated test 02 August 2004
- observed cavitated internal high pressure injector seals

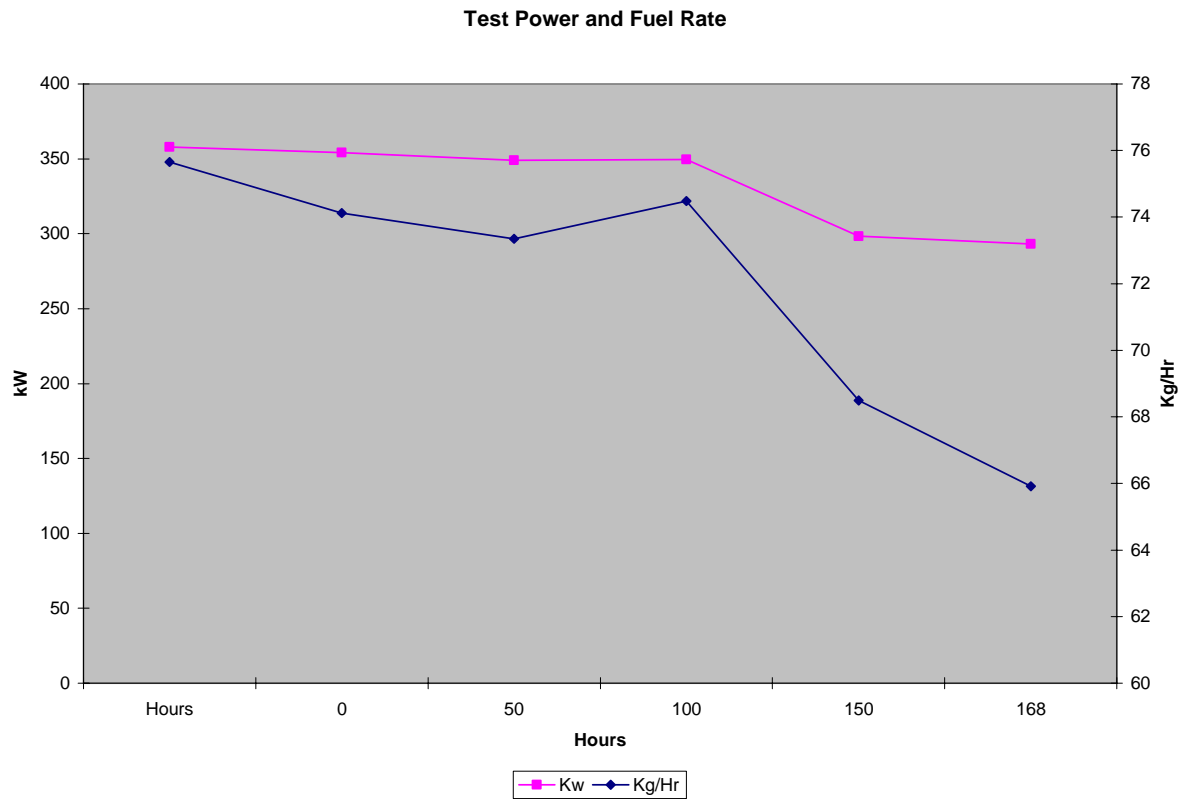
Graph V- 12.5 Liter Test Power and Fuel Rate – Run #2

- Start Run #2 17 February 2006 with new injectors; increased fuel rail charge pressure; improved fuel cooling
- Power/fuel rate loss; 8-15% 24 February 2006 @ 166 hours
- Same injector cavitation failure mode as Run #1
- Terminated test on 06 March 2006.

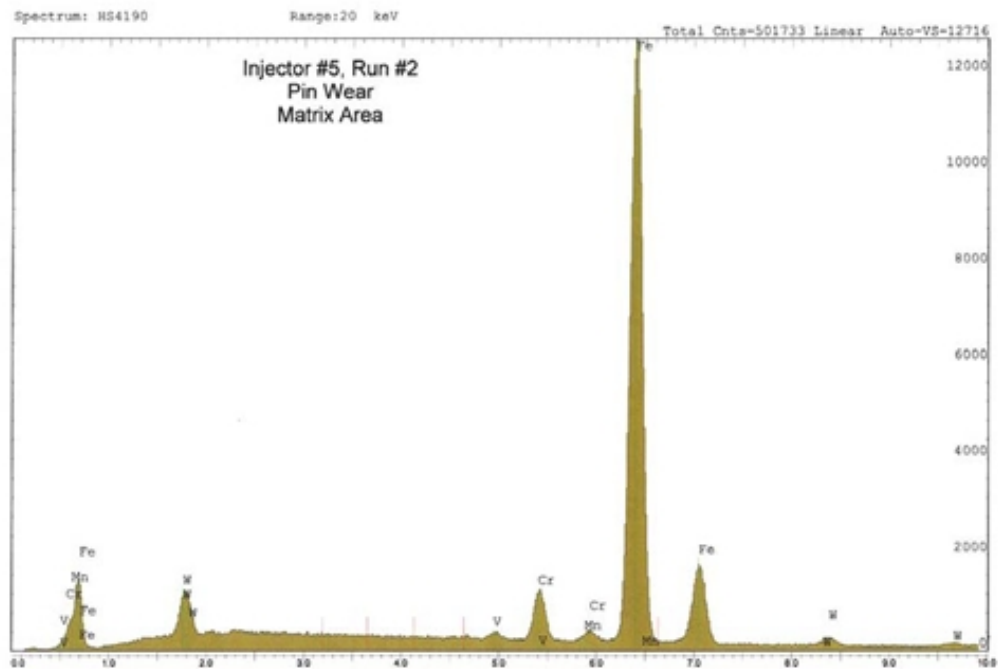
Examination of the second phase particles using energy dispersive x-ray spectroscopy (EDS) indicated that they were enriched in W, as shown in Figure 10. The matrix between the particles was iron based with small amounts of Cr, V, W and Mn, as shown in Figure 11. EDS measurements performed within the dark streaks, Figure 12, did not reveal any species besides those from the base alloy. For comparison, an EDS spectrum from an unworn area at the top of the needle, Figure 13, was also obtained. No significant differences were observed between this spectrum and those taken in the worn areas.

Figure 10. EDS spectrum from location 1 in Figure 9(b).

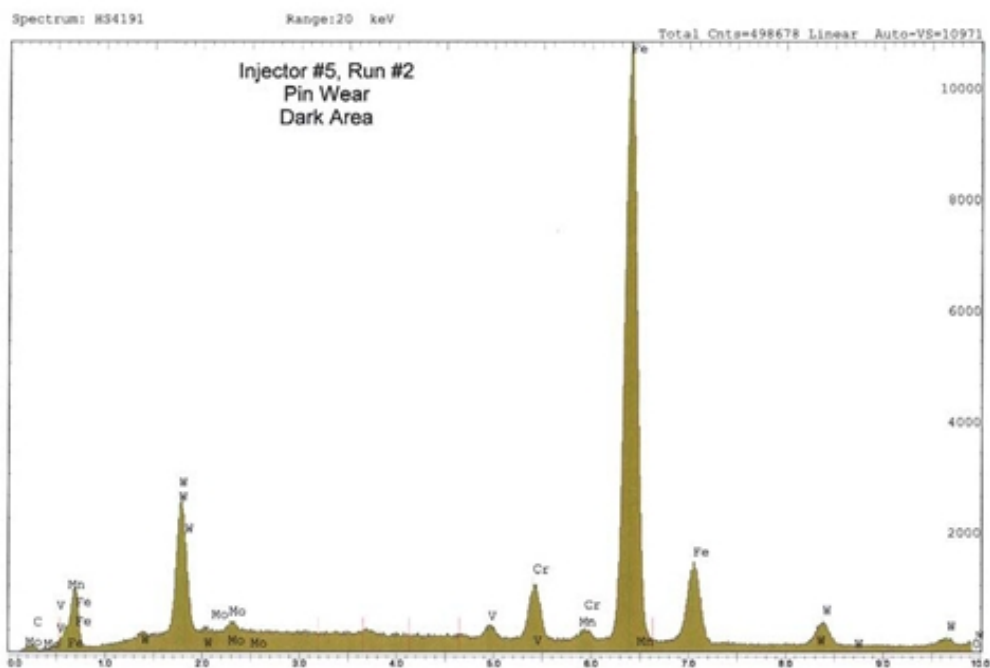
Figure 11. EDS spectrum from location 2 in Figure 9(b).

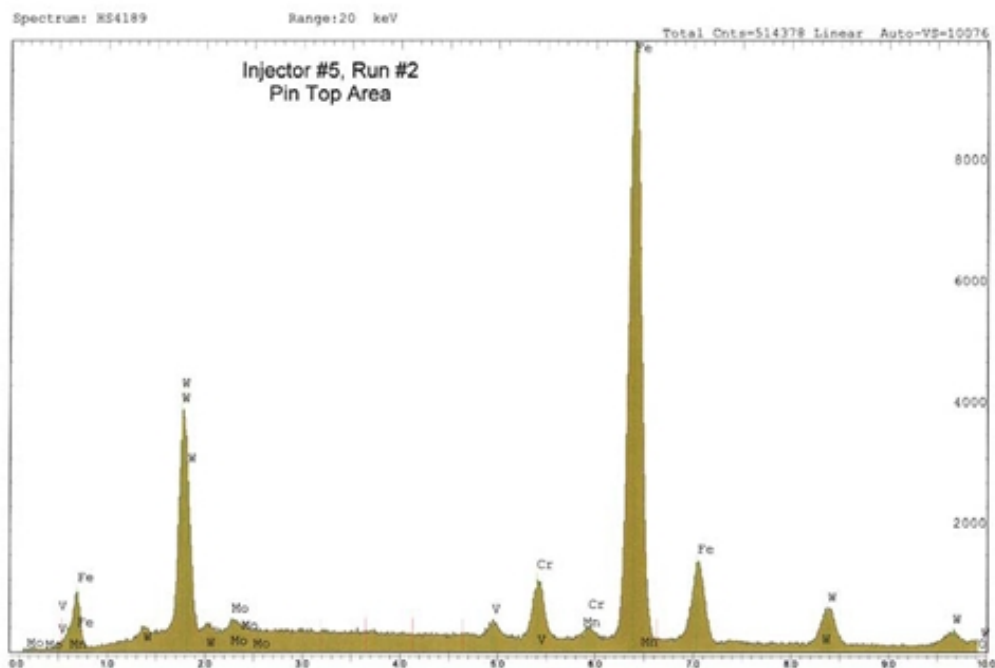
Figure 12. EDS spectrum from location 3 in Figure 9(b).

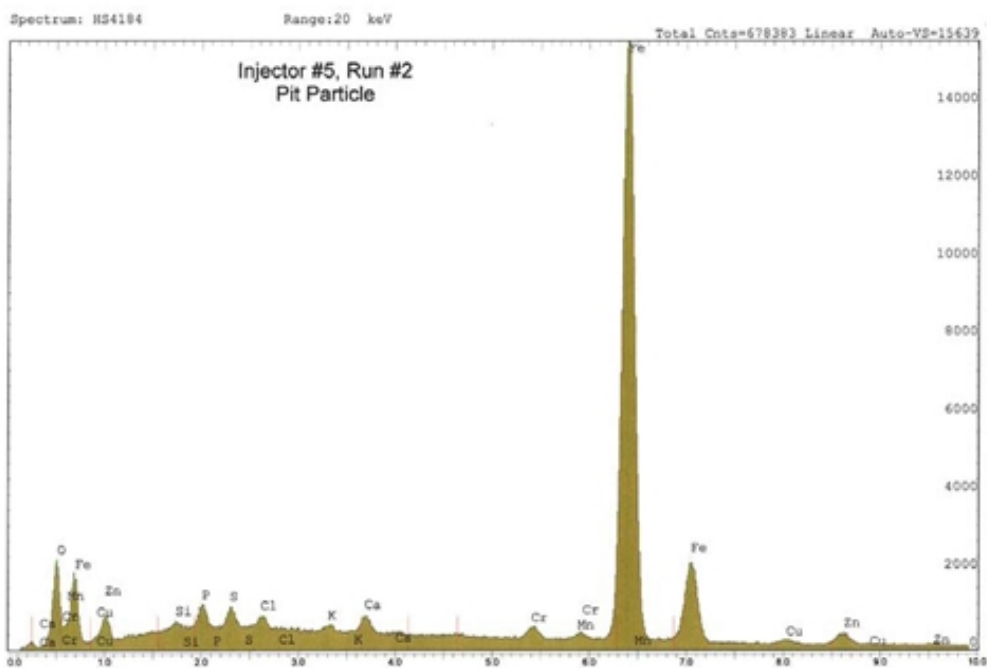
Figure 18. EDS spectrum from location 1 in Figure 17(a).
